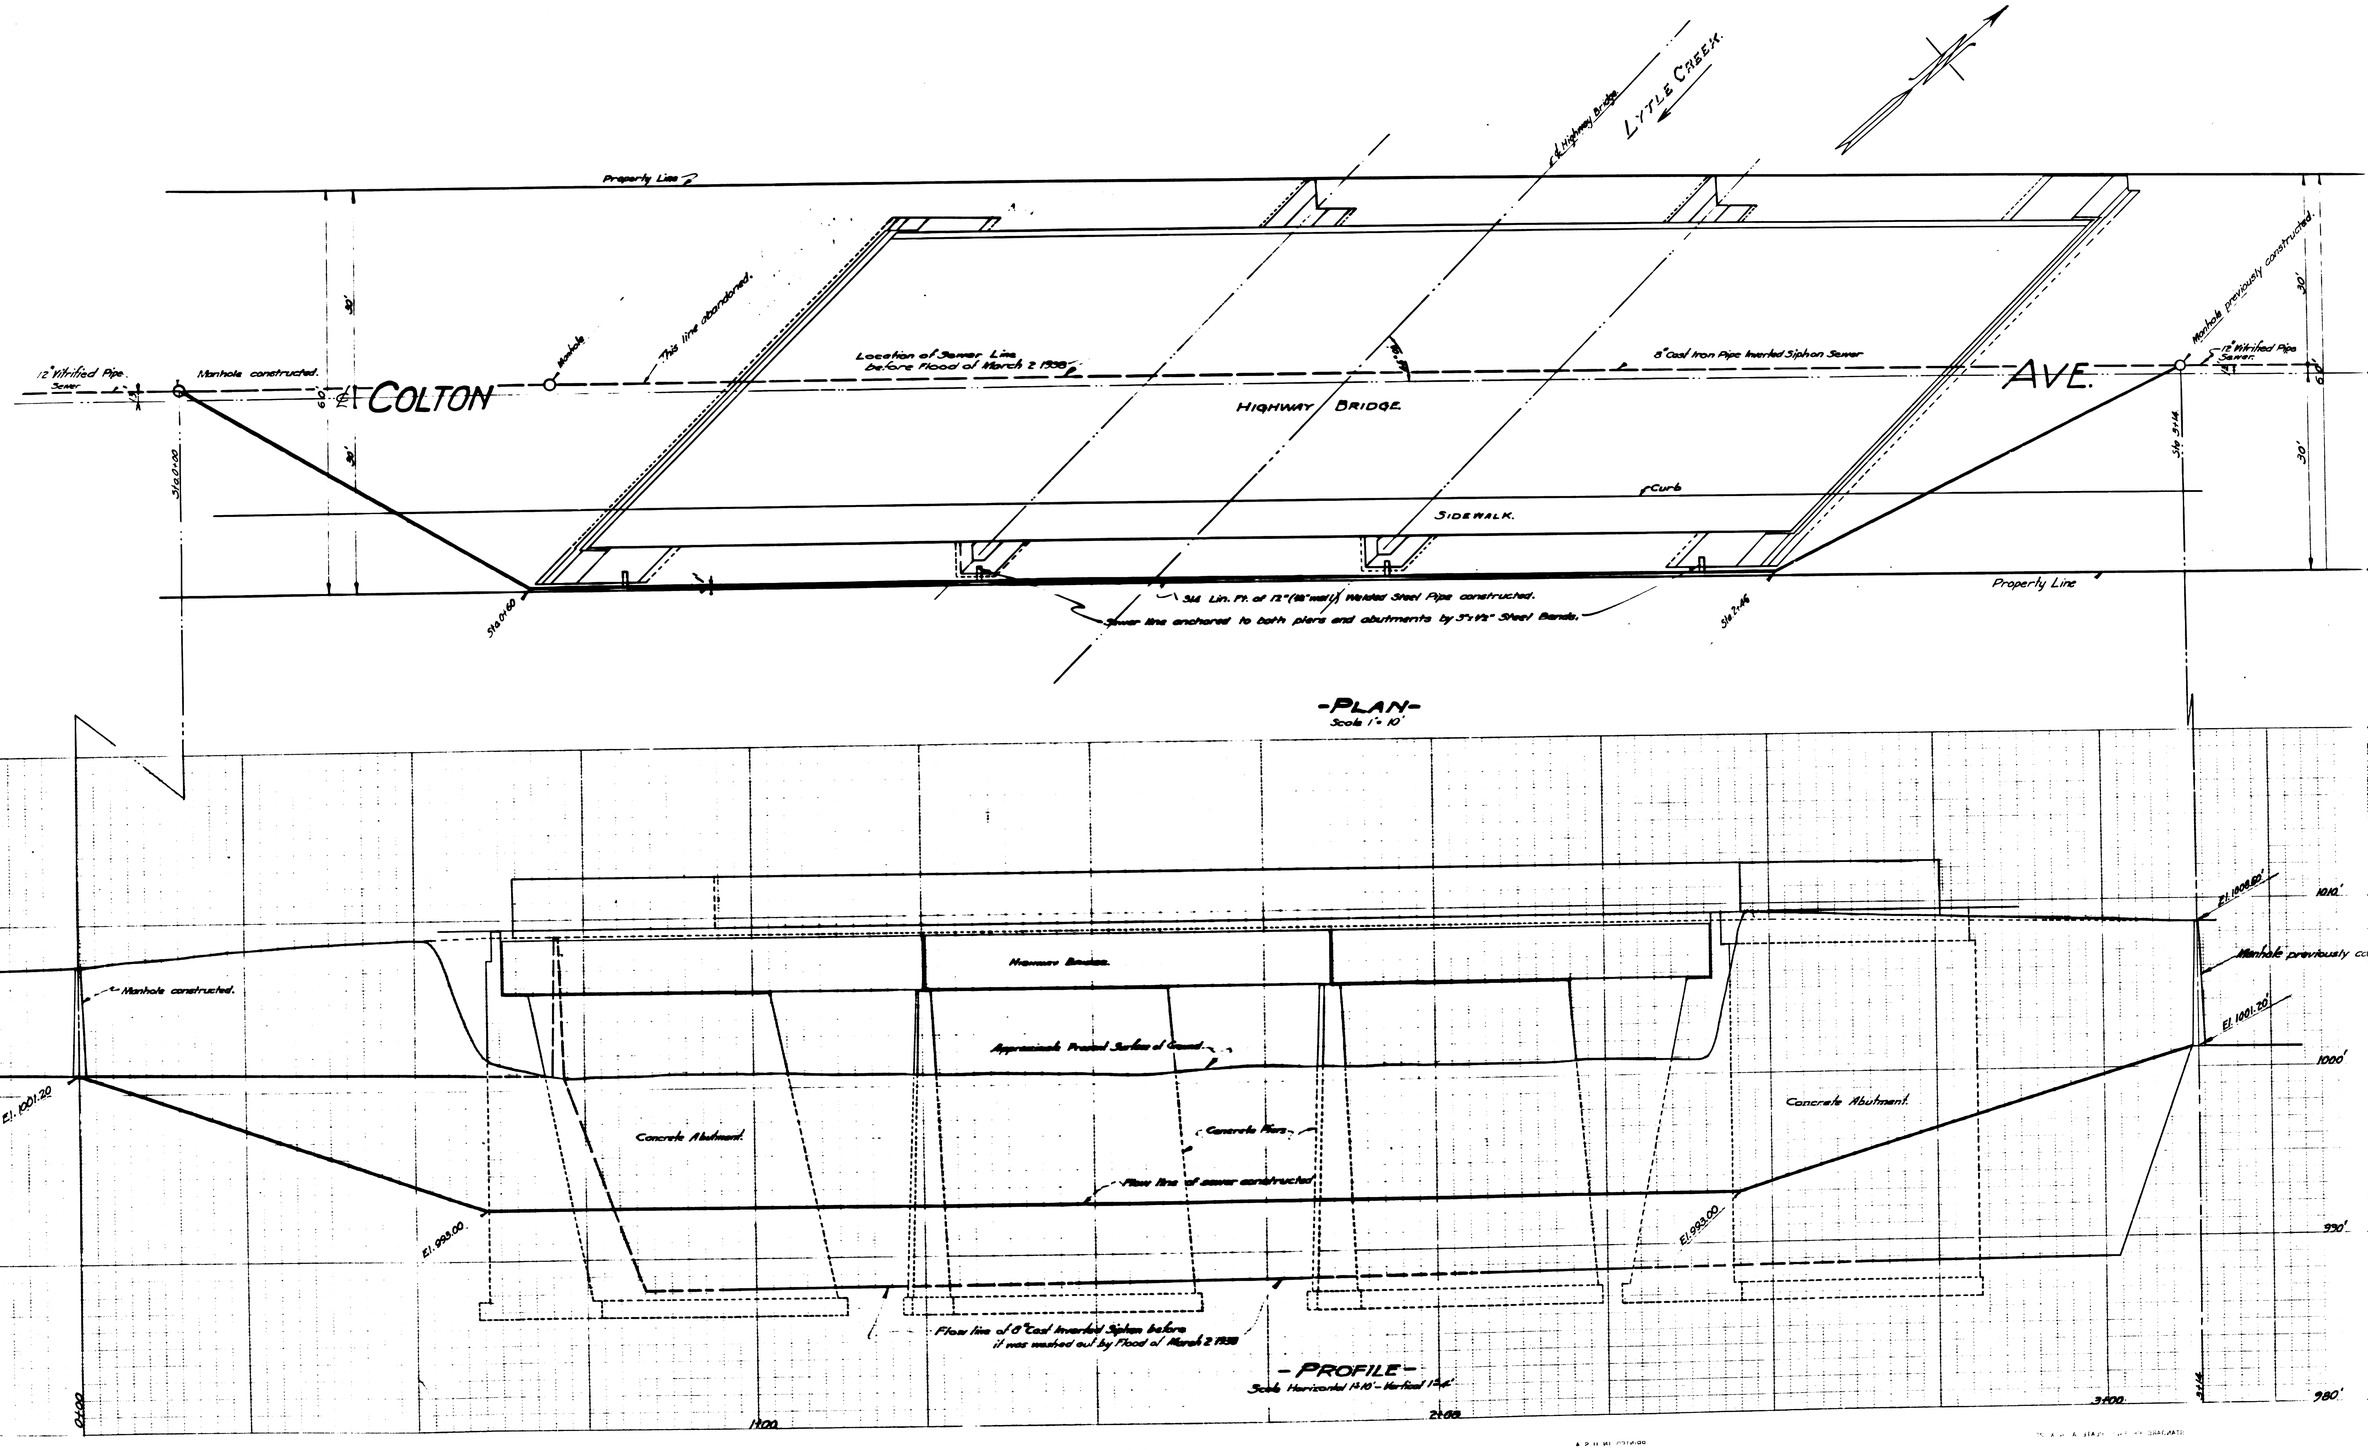
Property Line
℄ Highway Bridge
LYTLE CREEK
12" Vitrified Pipe Sewer
Manhole constructed.
Manhole
This line abandoned.
COLTON
Location of Sewer Line before Flood of March 2 1938
8" Cast Iron Pipe Inverted Siphon Sewer
AVE.
Manhole previously constructed.
12" Vitrified Pipe Sewer
HIGHWAY BRIDGE
Curb
SIDEWALK.
Sta. 0+00
Sta. 0+40
Sta. 3+48
Sta. 2+46
34 Lin. Ft. of 12" (.188" wall) Welded Steel Pipe constructed.
Sewer line anchored to both piers and abutments by 5"x1/2" Steel Bands.
Property Line
-PLAN-
Scale 1" = 10'
1010'
1000'
990'
980'
El. 1001.20
El. 993.00
Manhole constructed.
Manhole previously constructed.
Masonry Bridge
Approximate Present Surface of Ground
Concrete Abutment
Concrete Pier
Flow line of sewer constructed
Flow line of 8" Cast Inverted Siphon before it was washed out by Flood of March 2 1938
-PROFILE-
Scale Horizontal 1" = 10' - Vertical 1" = 4'
0+00
1+00
2+00
3+00
